# Manhole Inspection Summary

Manhole # S69S\_\_015MH

Insp Date: **4/3/08 10:04 AM**

**Location** Address: **6428 Hartwait St.**

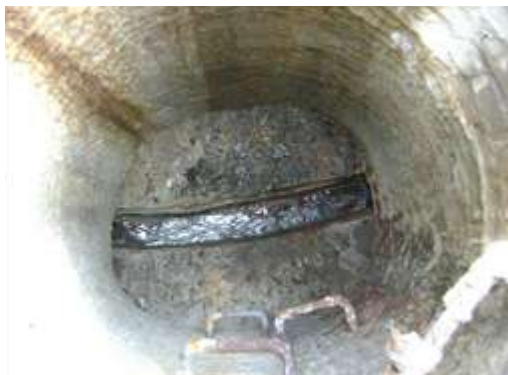
Defect 2

Condition: ☐ Sound ☐ Cracked ☐ Root Intrusion ☐ Deteriorated ☐ Leaks ☒ **Debris**

Debris on bench

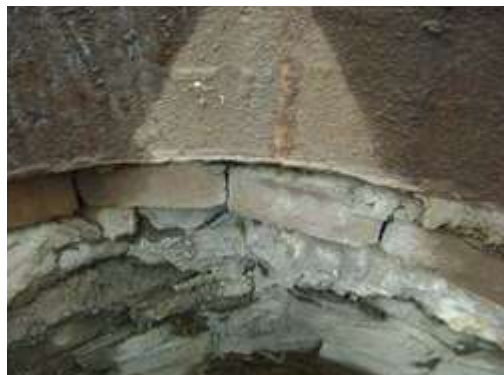
Defect 1

Condition: ☐ Sound ☐ Cracked ☐ Root Intrusion ☒ **Loose Brick** ☒ **Deteriorated**

Infiltration: ☐ None ☐ Joint ☐ Cracks ☒ **Mortar** ☐ Roots ☐ Wall

Deteriorating chimney/frame

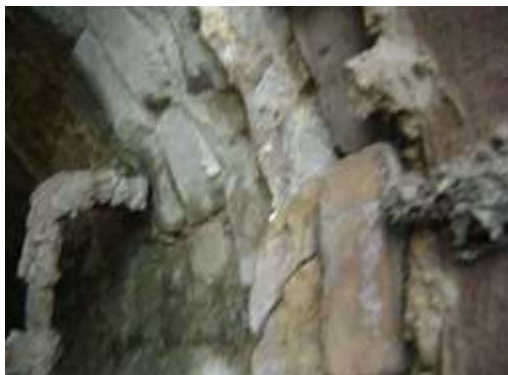
Defect 3

**Steps** Count: **4** Missing: **0** ☒ **Corroded**

Deteriorating chimney, corroded steps, loose bricks

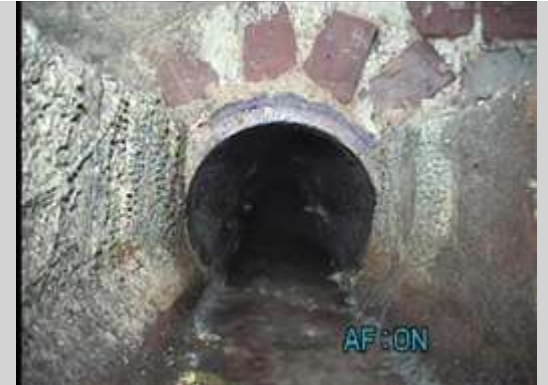
12 O'Clock Outflow

Pipe Height: **8.4** (in.) Rod and Bar (Angled)  
Pipe Material: **Clay** ☐ Pipe Lined  
Invert Depth: **9.17** (ft.) Flow Characteristics: **Fast**  
Deposits: ☒ None ☐ Mud ☐ Sludge ☐ Debris ☐ Grease  
Silt Depth: (in.) Deposits Extent:  
Infiltration: **None** Pipe Seal Cond: **Sound**

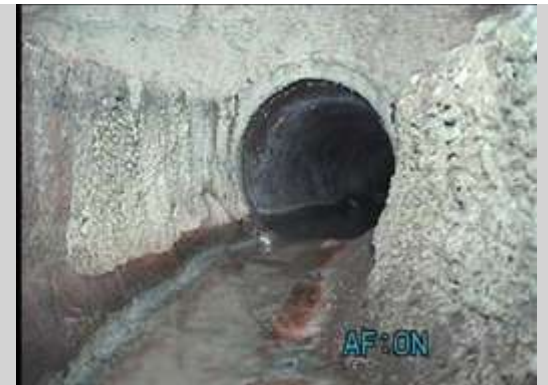
6 O'Clock Inflow

Pipe Height: **8.4** (in.) Rod and Bar (Angled)  
Pipe Material: **Clay** ☐ Pipe Lined  
Invert Depth: **8.79** (ft.) Flow Characteristics: **Fast**  
Deposits: ☒ None ☐ Mud ☐ Sludge ☐ Debris ☐ Grease  
Silt Depth: (in.) Deposits Extent:  
Infiltration: **None** Pipe Seal Cond: **Sound**
